Orbit Newsletter Digital Publication

Q2 2022

Gas Piping Condition Monitoring deployment

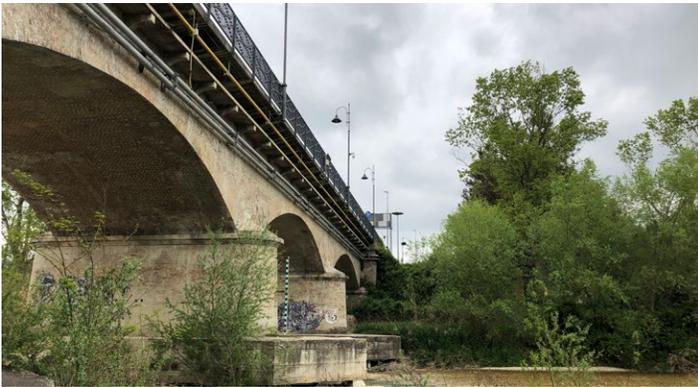
Fig 2: View from north side of the bridge from the bottom

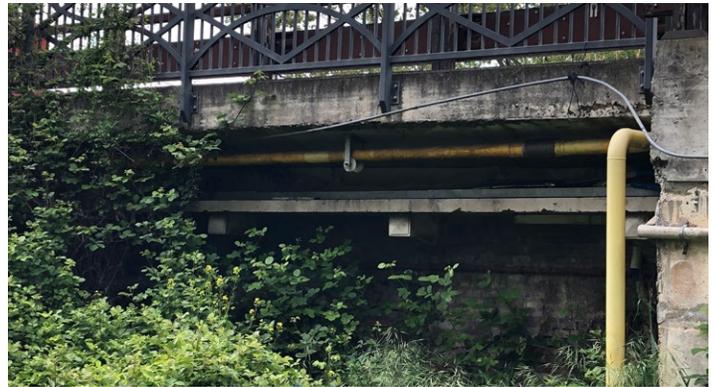
Fig 3: View of obstacles present on the south side of the bridge

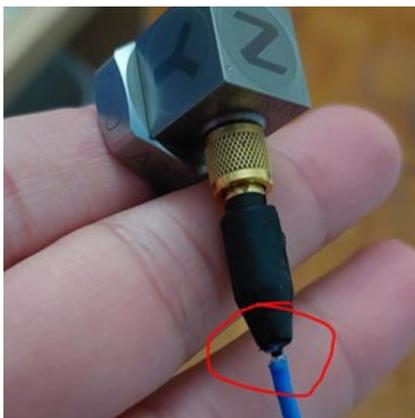
- Expectations: Data collected without any criticality till early afternoon
- Reality: At 16:00 the data began indicating some noise, and, after a loop check, there was the evidence of the triaxial cable being broken

Fig 11: Broken cable

As the activities were adequately planned the MDS Engineer utilized the backup single axis sensors to continue data collection. In addition the second crane was now present, thus the activity accelerated dramatically and the test was still finalized on time and the third day.

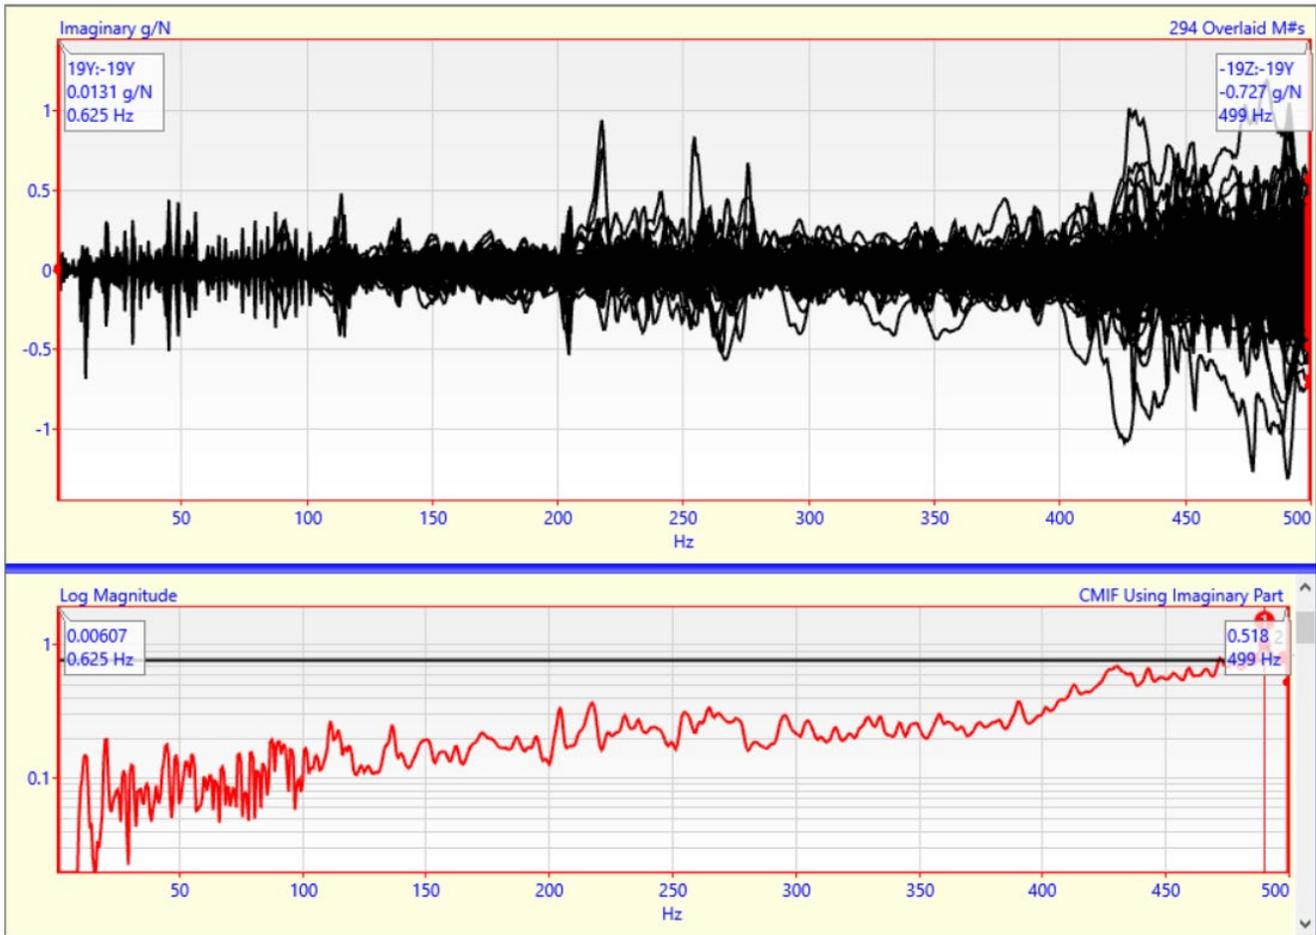
Fig 15: Global interpolation

Frequency (or Time)	Units	Damping (%)
490	Hz	0.269

The sources of excitation on the bridge and/or directly on the piping are not fully known and repeatable, these are mainly due to car/truck passing on the bridge and other phenomenon like earthquakes. These sources were expected to typically excite the low frequency range therefore, there was no clear need to extend the frequency range over 500Hz.

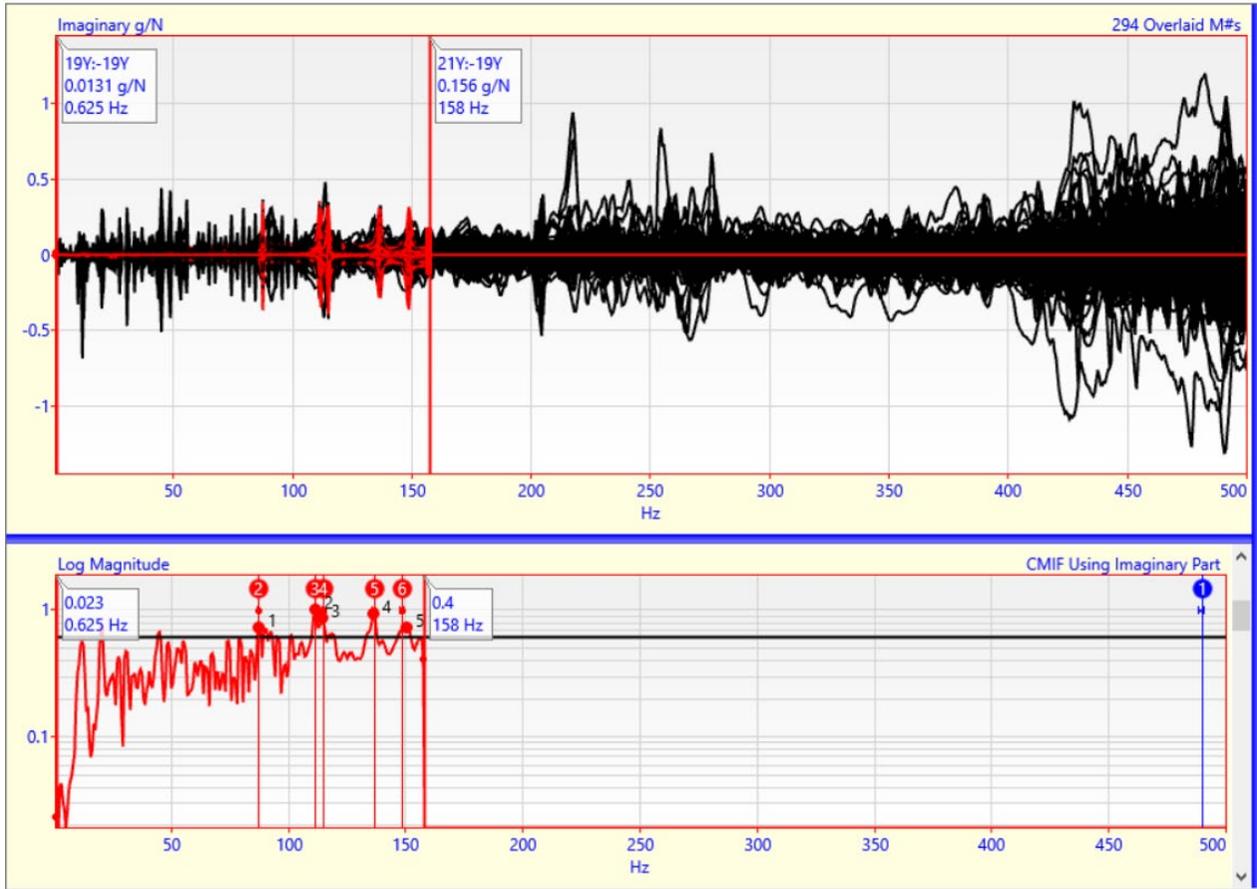
Fig 17: Local interpolation (0-158Hz)

Of course, with the source of excitation not being definitive, no segregation margin can be calculated between excitations and natural frequency. Other possible modes, in the lower frequency range were not apparent either due to a lack of excitation force from the impact hammer or were highly damped, so that no clear response can be seen while making an overall interpolation of the piping response. Therefore, some local interpolations were executed as shown in Fig 16 to Fig 19:

Modal Parameters		
Select Mode	Frequency Hz	Damping (%)
1	87.4	0.179
2	112	0.418
3	115	0.344
4	137	0.587
5	149	0.675

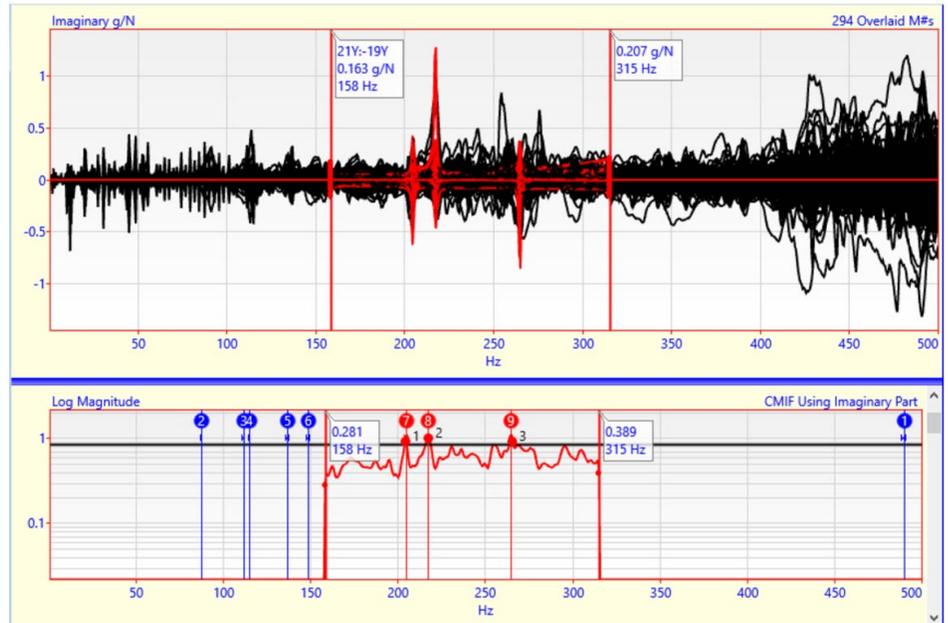
Fig 19: Local interpolation (158-315 Hz)

Modal Parameters		
Select Mode	Frequency Hz	Damping (%)
1	87.4	0.179
2	112	0.418
3	115	0.344
4	137	0.587
5	149	0.675

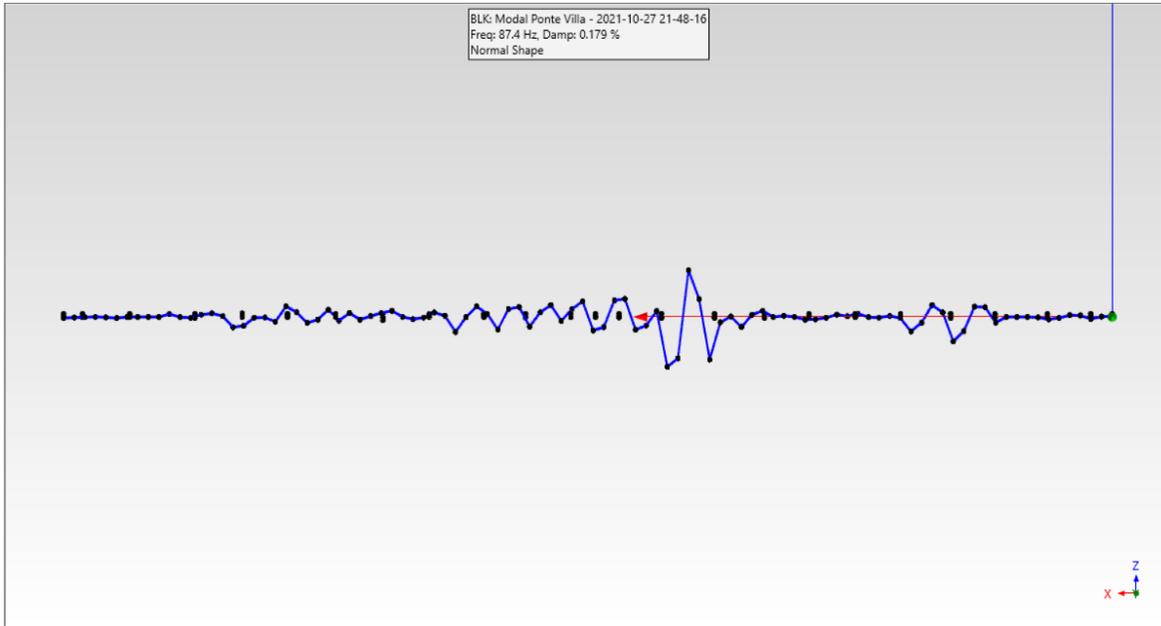
Fig 20 shows a mode shape, associated to one of the abovementioned natural frequencies, obtained by the overall interpolation.

Through comparison of all the mode shapes obtained from each natural frequency, a clear distribution of permanent probes installation was defined. Utilizing this approach would avoid sensors being positioned on nodal points which, from their definition, do not have a response for the related mode - thus no valid information would be retrieved with sensors positioned in those locations.

Fig 20: Mode shape related to the mode at 87.4Hz

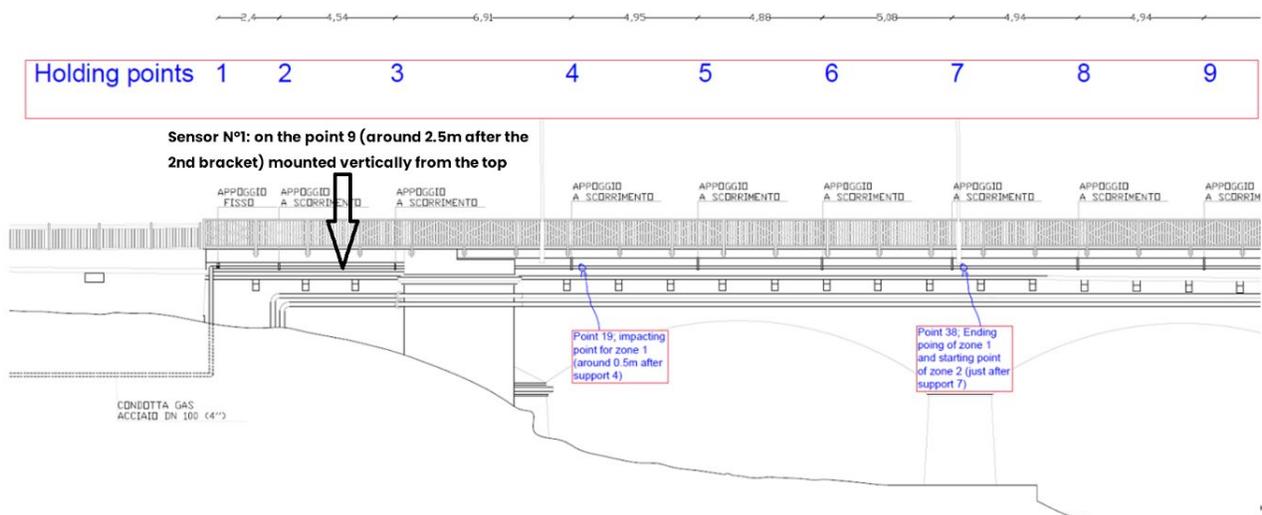
Fig 21: Example of sensors 1 location plan

An example of detailed instruction for the sensor installation is outlined in Fig 21 and a total of 12 sensors were planned to be installed on the piping:

- Sensor N°1: on the point 9 (around 2.5m after the 2nd bracket) mounted vertically from the top.
- The direction has been chosen also taking into account the ease and the integrity of installation considering the sensors too much exposed to atmospheric environment if oriented in horizontal direction.

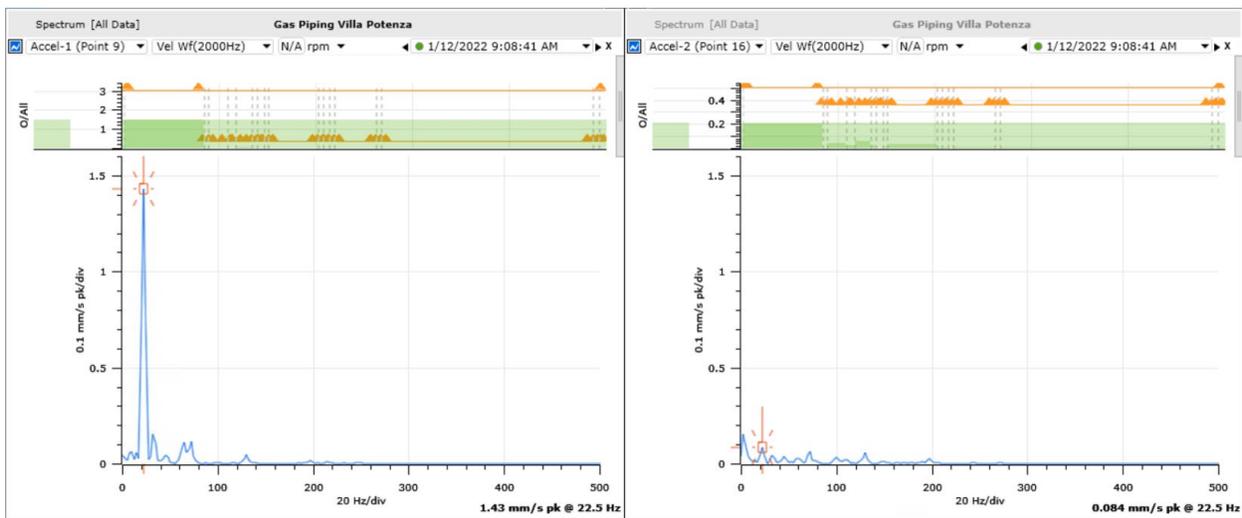
- No critical frequency seems to be excited at the moment, neither in normal condition nor in exceptional vibration events.
- The behavior of the probes is repeatable (under the aspect of frequency components) and also as daily evolution of overall amplitude, verifying the health of the monitoring system.

- As expected, the sensors installed closer to the brackets are showing a lower overall amplitude.
- The excitation frequencies seem to be mainly 2.5Hz, between 12.5 and 15Hz, between 22.5 and 25Hz and finally between 45 and 50Hz.

- During vibrational events, the amplitude seems to be increasing in correspondence to these known frequencies and no different spectral pattern could be seen.

Fig. 27: Zoom between 0 and 500Hz of the current spectrums of velocity signal for the probes 1 and 2

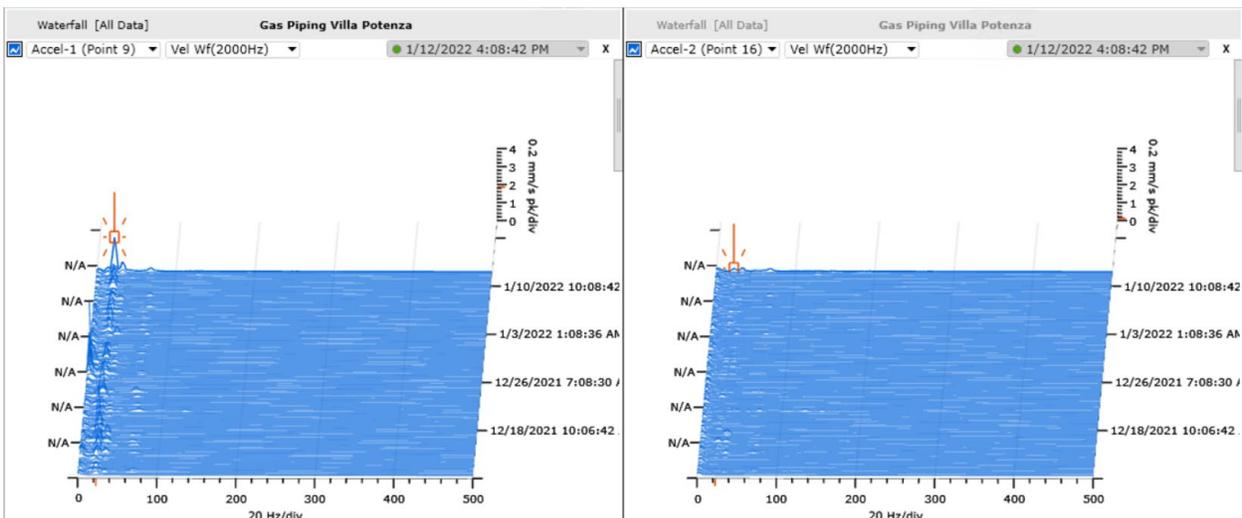
Fig. 28: Zoom between 0 and 500Hz of the current Waterfall spectrums of velocity signal for the probes 1 and 2
