Orbit Newsletter Digital Publication

Q4 2021

Monitoring gearboxes ...an Orbit article

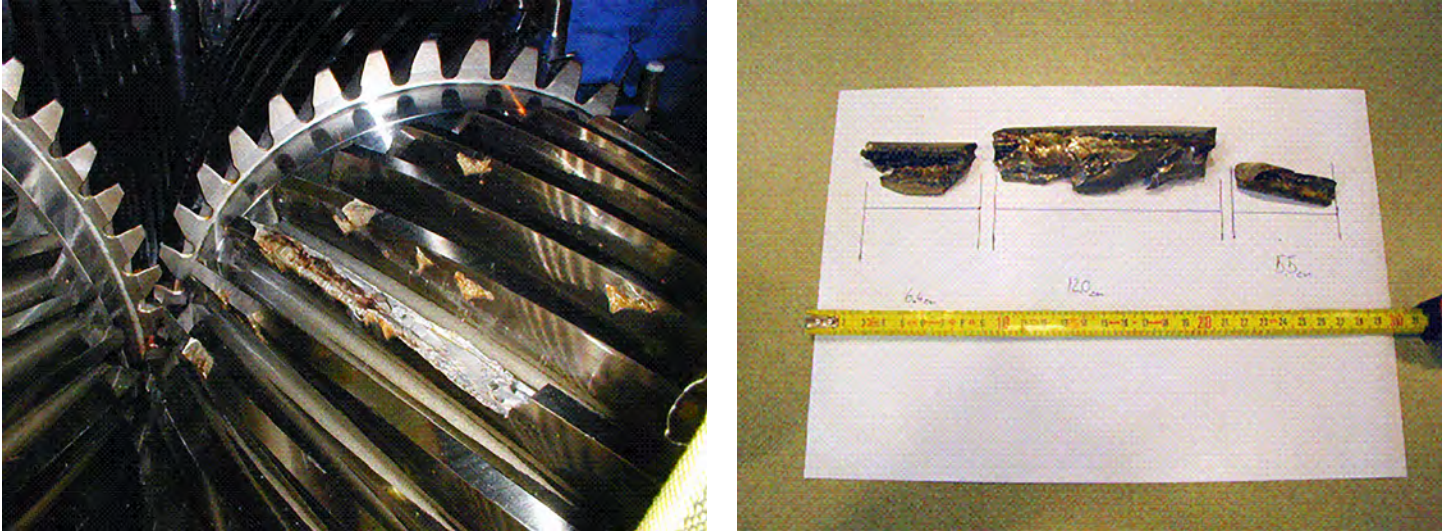
This single reduction stage GB was instrumented according to BN recommendation, so XY proximity probe pair on each bearing and three accelerometers on the GB casing. The first symptom showing a problem was increased vibration, both in acceleration and velocity. This was followed by increase of shaft vibration, especially on the blind end of the high speed shaft. A detailed analysis gave reason to believe that at least two teeth of the pinion have failed. The machine was stopped and indeed several teeth on the pinion had failed, and lost of material was on the blind end, see Figure 2.

Figure 2. Failed high speed GB and the missing parts found inside the GB casing

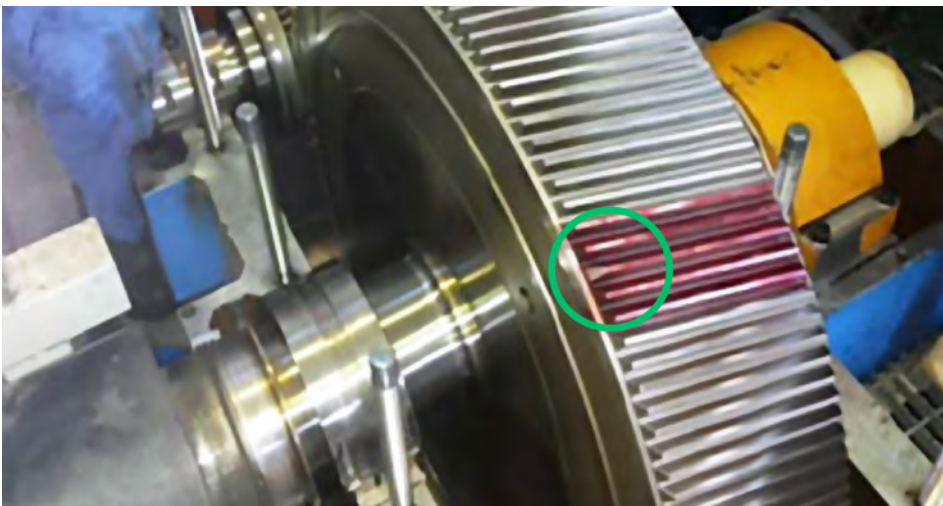
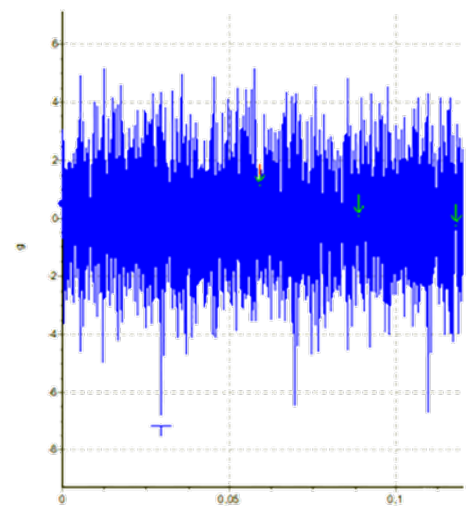
This GB has no vibration instrument and we do routine data collection with portable Scout instrument. The first time the data was collected we noticed quite high impact seen on the acceleration waveform. The impact seemed to take place once per revolution. A time synchronous averaged data was collected in order to gain a higher confidence of the issue. This clearly showed single teeth was impacting when entering the mesh. On the next overhaul GB was opened and it was found one tooth end had a different profile from the others.

Figure 3. One tooth causing impacts

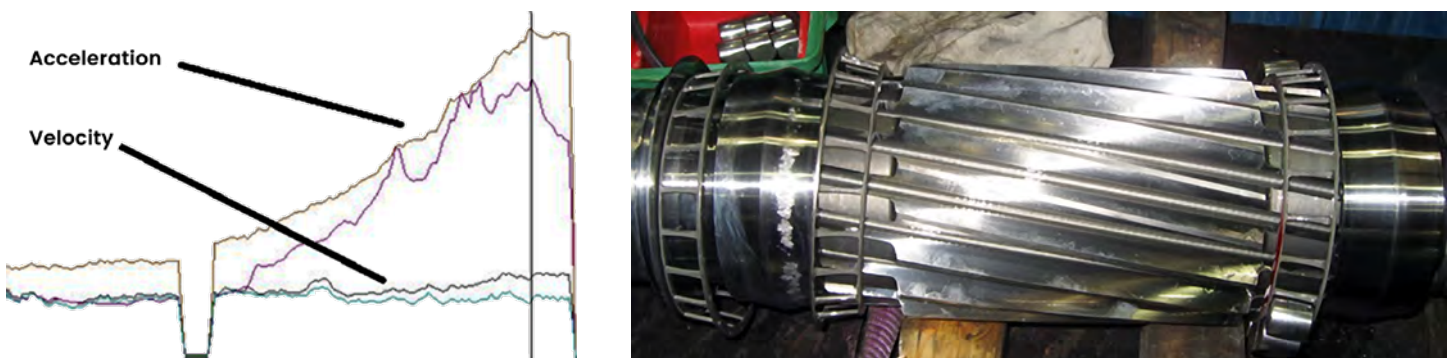
Ethylene plant has four seawater pumps, all equipped with BN 1900/65A monitors and multiple accelerometers. After an overhaul high frequency acceleration values started to increase on one of the GB, while velocity readings remained stable, figure 4. Additional analysis was performed with portable instrument and this showed symptoms of REB failure on GB high speed shaft. After trending the situation for a couple of month GB was overhauled and failed bearing was replaced.

Figure 4. Vibration trends on DCS and high speed shaft bearing inner ring failure

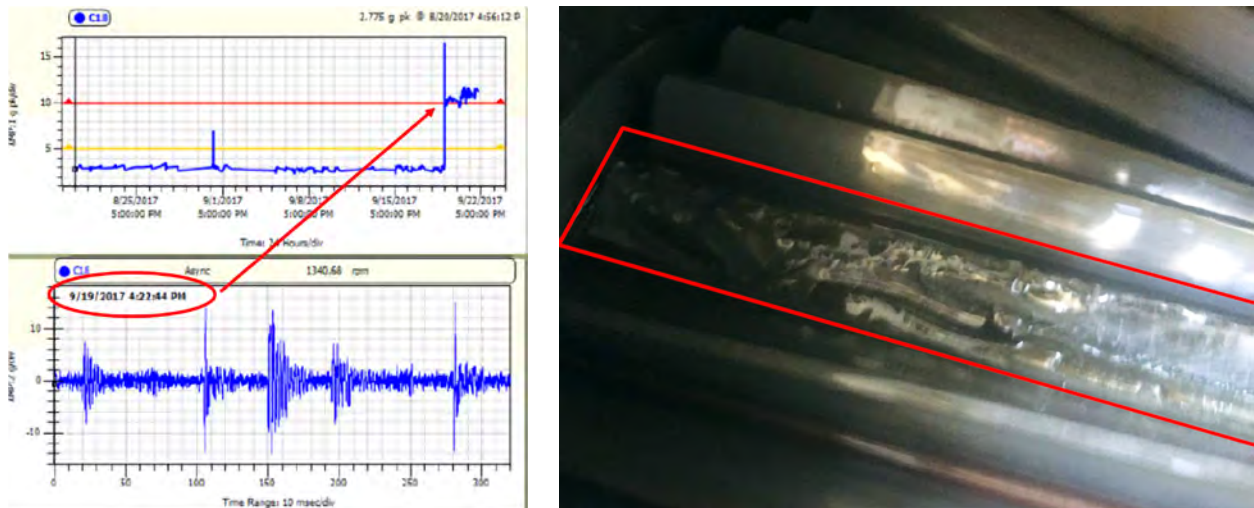
A significant step change on vibration trend was observed on GB, figure 5, using BN Wind.Adapt monitoring system. The spacing of the impacts suggested problem on an intermediate shaft. A borescope inspection confirmed this, by showing a broken tooth.

Figure 5. Vibration change due to a broken tooth

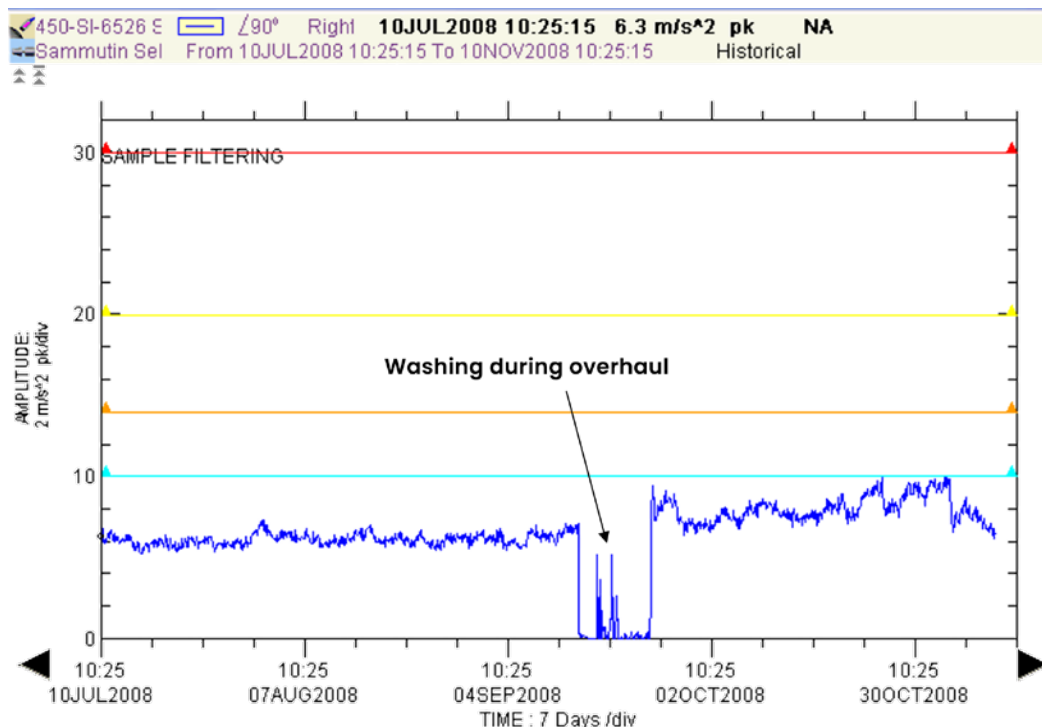
A pulp mill mixer is driven by an electric motor and four stage GB with output about 6 rpm. System is instrumented with several accelerometers and System1 condition monitoring SW. During an overhaul the mixer blades were washed and after the unit was put back in operation the vibration values started to slowly increase. Condition monitoring group investigated the issue and finally came into conclusion that mixer is rotating into the wrong direction. The washing process required rotation into both directions and by human error the wrong direction was left on. Not only does the mixer work less effective but also there is a high risk of damaging GB as it is designed to operate only to one direction.

Figure 6. Trend indicating something is going on with the mixer GB
