Case study: China

LeakID test quickly identified type and location of dangerous cooling tower leaks

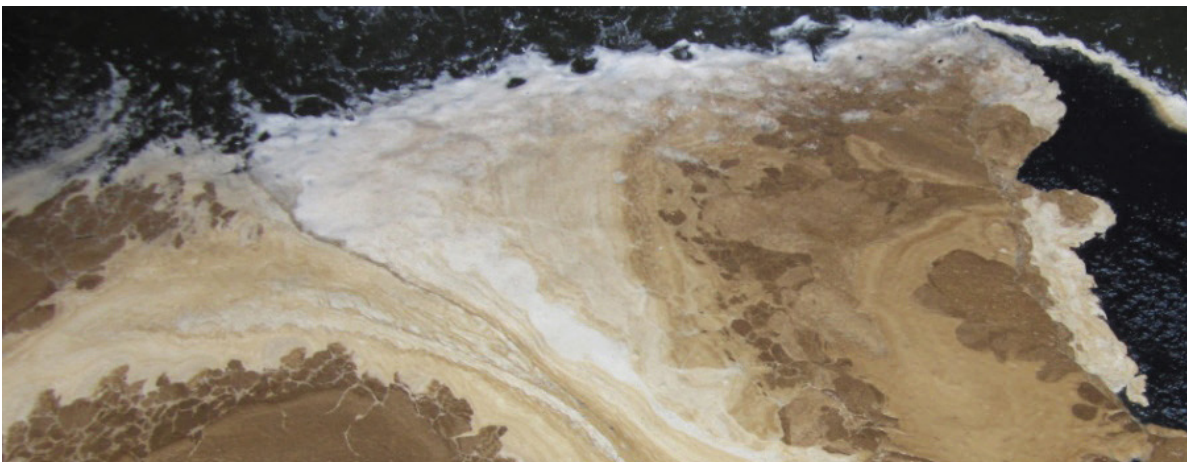
Hydrocarbon leak in cell one of north cooling tower basin.

- Remove the leaking heat exchanger from service and repair
- Maintain a constant free available chlorine (FAC) residual of 0.3 to 0.7 ppm to control microbiological growth
- Monitor sessile bacteria with a Baker Hughes customized corrosion and sessile monitor
- Use LeakGuard™ leak detection and mitigation services to control hydrocarbon leaks

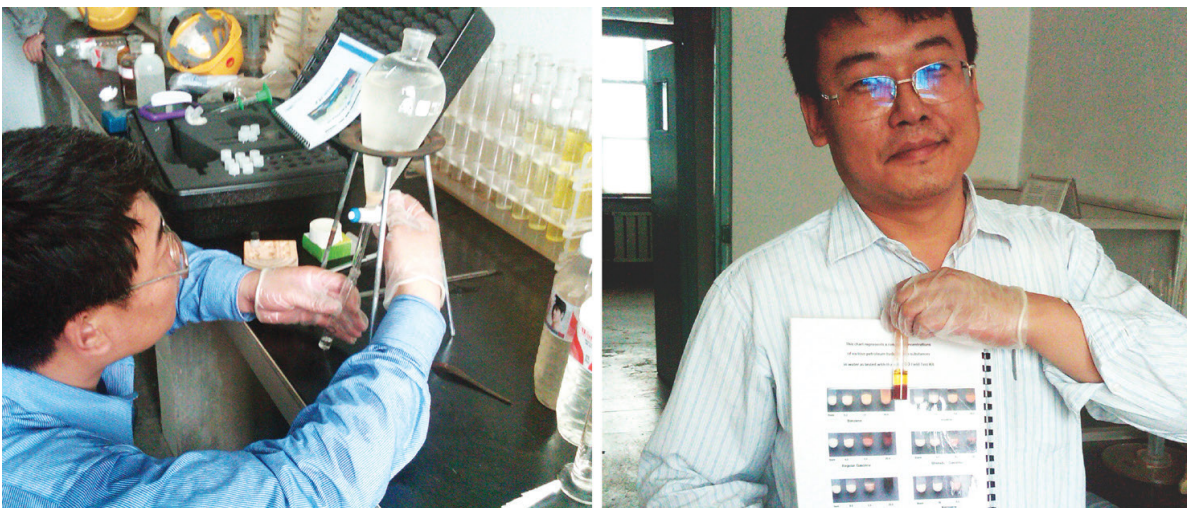
The LeakID test is a proprietary investigative tool used by Baker Hughes engineers to identify and quantify the type of hydrocarbon leaks in cooling water systems. The refinery had several possible locations for benzene leaks.
