## Application note

# Gas Spheres

### Gas sphere inspection

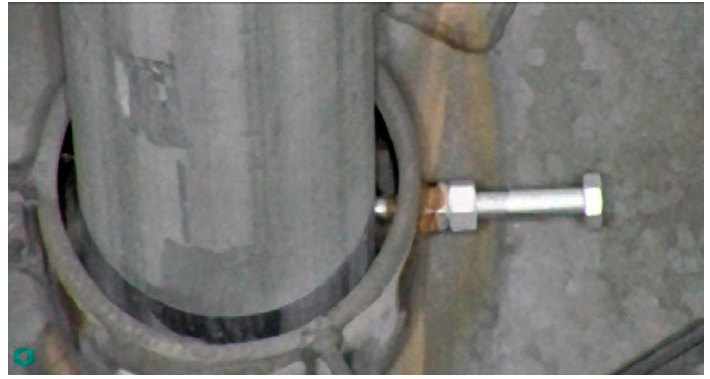
Picture taken from approx. 9 meters.

- **Superior image quality:** The Everest Ca-Zoom HD camera boasts a 30x optical zoom and HD resolution, enabling clear and detailed visualization of items from far away. The image quality aids in being able to identify damage and spot corrosion.

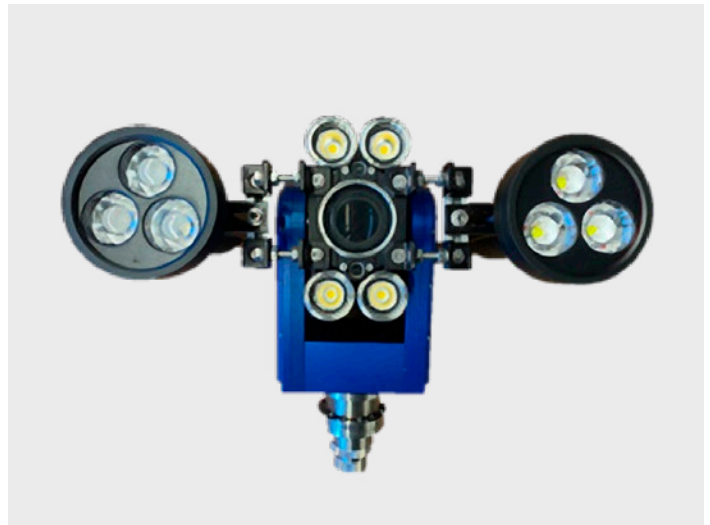
Additional lights from LED Lenser P18R mounted to the Everest Ca-Zoom HD30 provide extra 5000 lm.
