PROCESS & PIPELINE SERVICES

Managing corrosion and metal loss

Improving your asset's safety, integrity, and profitability

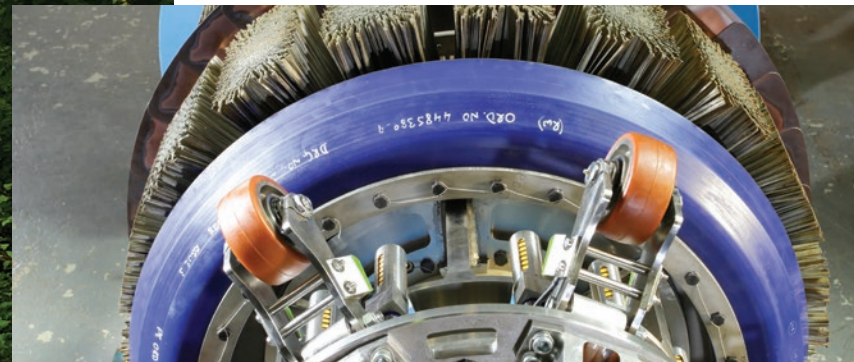
Heavily corroded and difficult-to-access pipelines

VECTRA™ GEMINI HD and **MagneScan™ SHR Plus** are our highest-specification in-line inspection tools. They deliver the best possible information to address your most complex challenges—enabling more reliable decision-making, ultra-high confidence, and significantly fewer digs. VECTRA HD has twice as many sensors as other MFL tools. The result is a more accurate picture than ever before—one that enables early detection and pinpoint accuracy of even the smallest instances of metal loss and complex corrosion. MagneScan SHR Plus has 4-in-1 sensor technology that makes it possible to identify linkages between individual pits/pinholes and the formation of NAEC as well as circumferential slotting and grooving. These tools deliver extremely high accuracy for depth, length, and width—making them particularly well suited to lines with extensive complex corrosion, high failure consequences, or the likely presence of axial defects or pinholes. The end result is the high confidence needed to only dig and repair what is absolutely necessary—the savings here significantly outweigh the incremental cost of the higher-specification inspection.

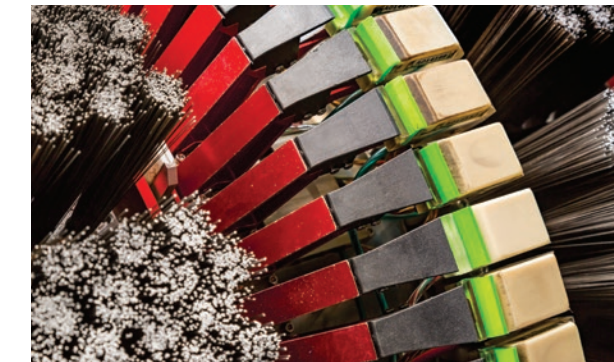
Pinhole corrosion

Very small pinholes can cause major problems—leaks. Whether caused by external microbe-induced corrosion or internal pitting, pinholes are always extremely difficult to detect. Our highest-definition tools have the capability of detecting pinhole-sized features, and seeing the most minute areas of metal loss. VECTRA HD, for example, has industry-leading sensor resolution, and yields multiple data sets in a single run—resulting in a sharper view that more accurately locates, identifies, and sizes complex anomalies such as pinholes. On top of inspection tool capabilities, we're constantly improving our algorithms and models so our analysts can more accurately quantify these difficult features. All in all, your advantages are reduced maintenance costs and less lost revenue, in exchange for increased uptime, fewer digs, and improved safety.

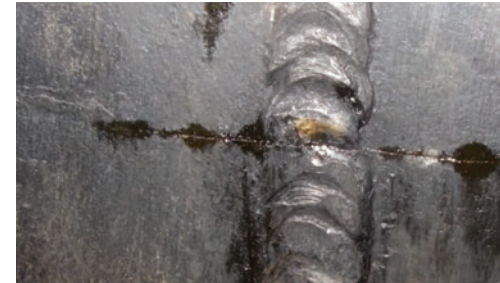
Girth weld cracking

Cracks in girth and spiral welds have been causing operators concerns for a number of years; but finding a reliable inspection solution has been challenging. Advancements in our MagneScan and VECTRA technologies have led to increased confidence levels in detection and sizing of these features with MFL technology. We've gathered a large database of actual pipeline defects, alongside manufactured defects, to develop a bespoke analysis process and associated report specifically for girth and spiral welds. This is now proven to be a reliable solution for operators who know they have pipeline construction concerns, and need to better focus their integrity and maintenance budgets.
