Case study: Northeastern United States

Cooling water treatment program using DemandTrac 900 reduces iron fouling in a Northeast refinery

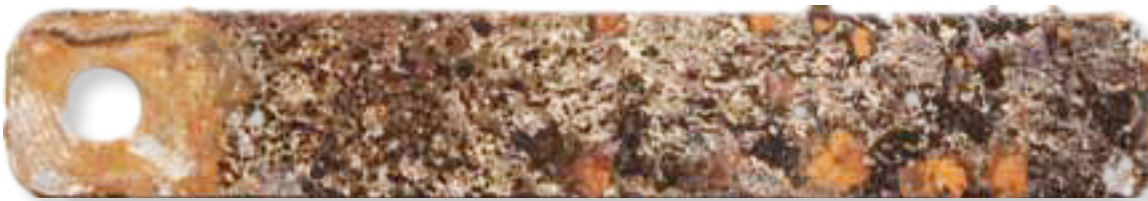
Before using DemandTrac 900 ter-polymer. (coupon was hand washed).

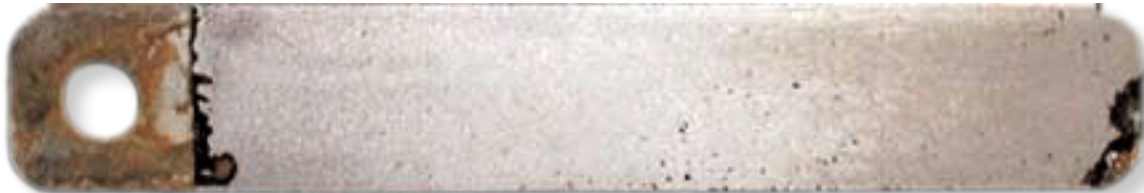
After using DemandTrac 900 ter-polymer. (coupon was hand washed).

importantly, the deposits found on the tubes were much softer and easily removed by normal pressure washings. The Unit Superintendent commented in a Systems Review meeting in front of all other supervisors, *"This is the best opening and quickest we've turned around this exchanger in 30 years!"* Shortly after this meeting, DemandTrac 900 internal treatment agent was in all of the remaining cooling towers in the refinery.
