# Efficient single run – multi ball seat PRIME Milling operation

Wintershall Dea had a new and critical offshore water injection well which was not performing as expected, having an injection rate well below target.

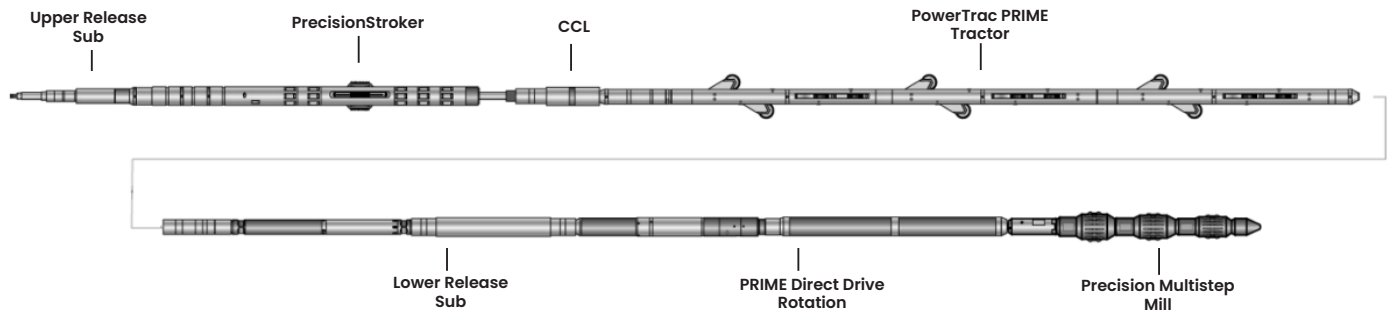
### Toolstring used for the milling operations

incorporating a high level of instrumentation for real-time measurement and control of parameters that are critical to milling optimization. The **PowerTrac PRIME Tractor** would provide high speed toolstring conveyance of the milling assembly to task depth. Once there, it would then provide rotational anchoring and weight-on-bit (WOB) in support of the milling task across the horizontal well section.

Tension/compression subs placed above and below the tractor would provide in-situ measurements of the WOB throughout the operation. The **PRIME Direct Drive Rotation** device would provide the rotational torque.

Monitoring and adjusting the torque, WOB, and rotational speed in real-time would enable an optimized rate of penetration throughout all steps across all ball seats, handling the spread of ball seat dimensions confronted during operation. The weight on bit would be adjusted by regulating tractor forward force, to keep the milling rotational speed and torque within the optimum operating range that was determined during pre-job tests.

A **PrecisionStroker** was also added to the toolstring to enable immediate high force pulling capability to free the toolstring if it were to get stuck in hole. As a further precaution, controlled release subs were also included in the string. Neither of these contingency measures were required for the operation.

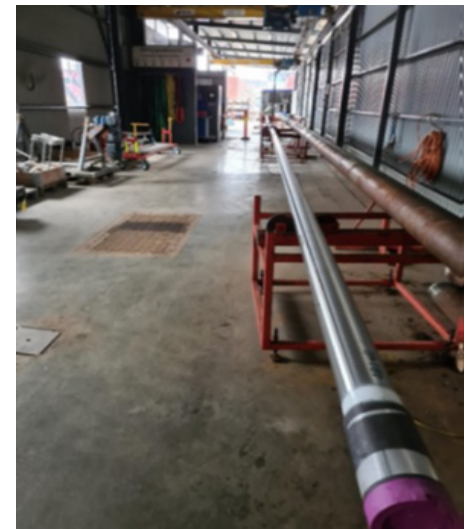
### Ball seats provided to engineering for milling tests

Thorough pre-job tests were carried out at our engineering facility on identical ball seats that were placed in a test-jig set up.

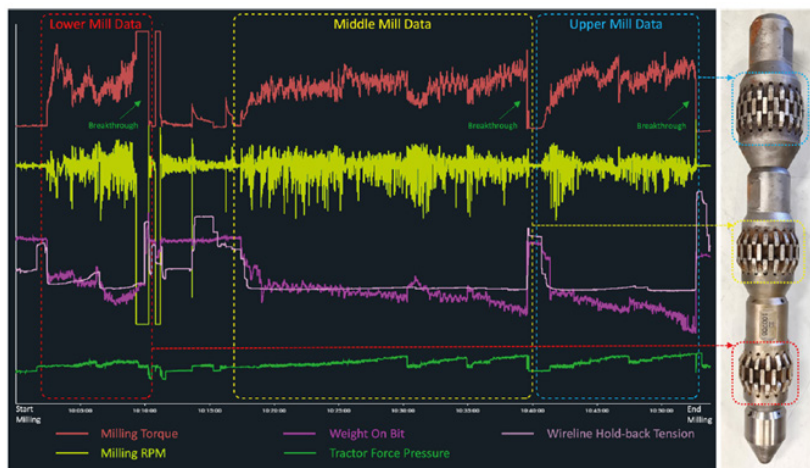
Example log data taken from a pre-job test done at the onshore engineering facility

Critical tool parameters captured in real-time during the testing provided clarity and understanding of the milling sequence of each ball seat, with mill engagement and breakthrough of each mill clearly determined from the multitude of toolstring data curves available.

Typical indications of milling progress seen via surface readout are user-increased weigh-on-bit resulting in increased milling torque and reduced milling rpm; and increased downhole wireline tension as the tool mills further into the ball seat.

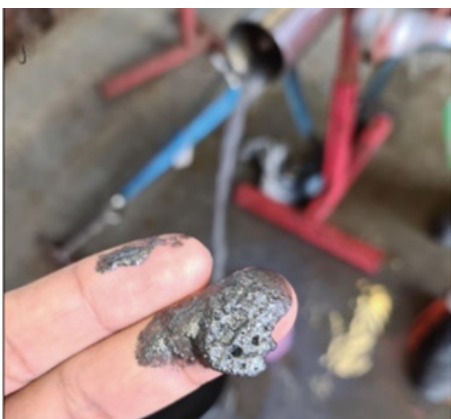
Swarf collected following milling tests

The swarf produced by the milling operation was found to be powder like, leaving no concern with regards to hindrance of the subsequent electric line perforation runs or a detrimental impact on the well injectivity.
