## Application note

# Measuring the flow rate to detect leaks on a blast furnace gas transportation line

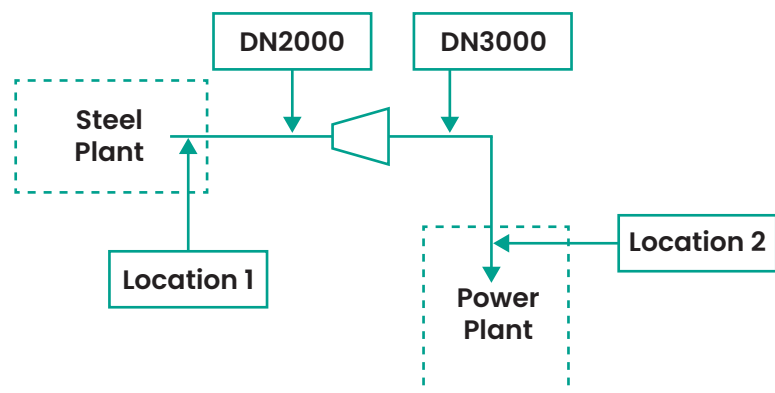
Figure 1: Installation schematic

The customer needed to monitor the flow to detect leakages; therefore, one GM868 was installed at the customer site on an 80 in. (2000 mm) pipe. The other meter was installed at the power plant on a 120 in. (3000 mm). The pipe expands from 80 to 120 in. approximately 0,62 m (1 km) before the power plant. See Figure 1 below for meter locations.

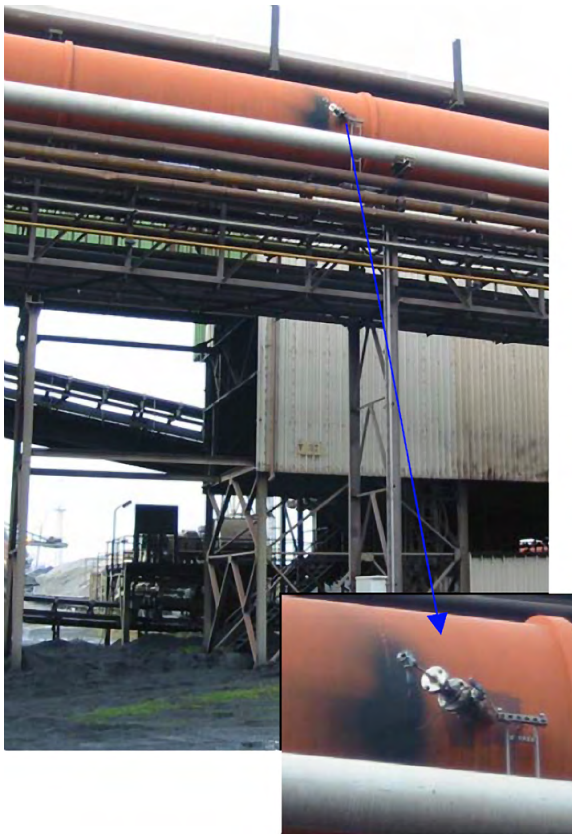
Figure 2. Customer installation site

The transducers for both meters were installed in a diametrical 45° setup in horizontal plan to avoid liquid collection in the nozzles to prevent transducer or insertion mechanism malfunctions (see Figure 2 below). The transducer heads were flush with the inside pipe wall to protect the transducer from small dust or liquid particles.

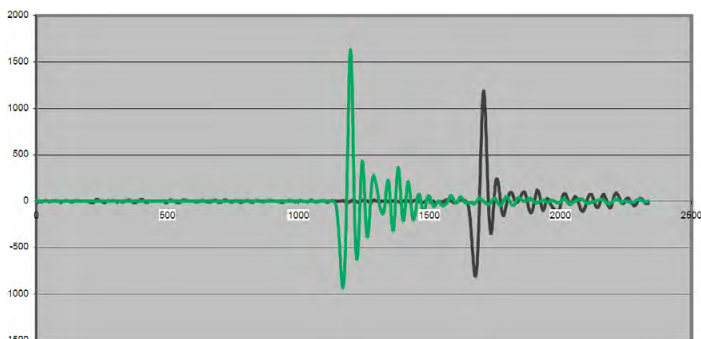
Figure 3. Ultrasonic signal from GM868 installed on 80 in. (2000 mm) pipe

Figure 3. below shows the ultrasonic signals taken on the 80 in. (2000 mm) pipe at a velocity of 118 ft/s (36 m/s). As shown the signal is clearly visible and the noise level is almost zero.

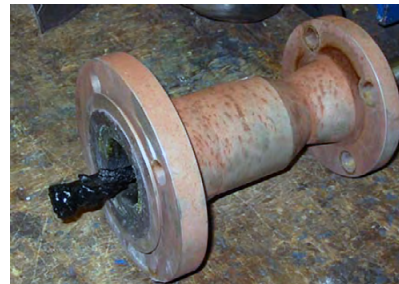
Figure 4. Upstream transducer removed for inspection

After almost one year of operation, the transducers were removed for evaluation. The meter was performing flawlessly even with a dirty tar-like buildup from the blast furnace gas on the transducers. Figure 4 shows an upstream transducer coated with dirty tar-like buildup.
