Modernizing

Nuclear TIPS

Upgrading the traversing in-core probe system in Boiling Water Reactors

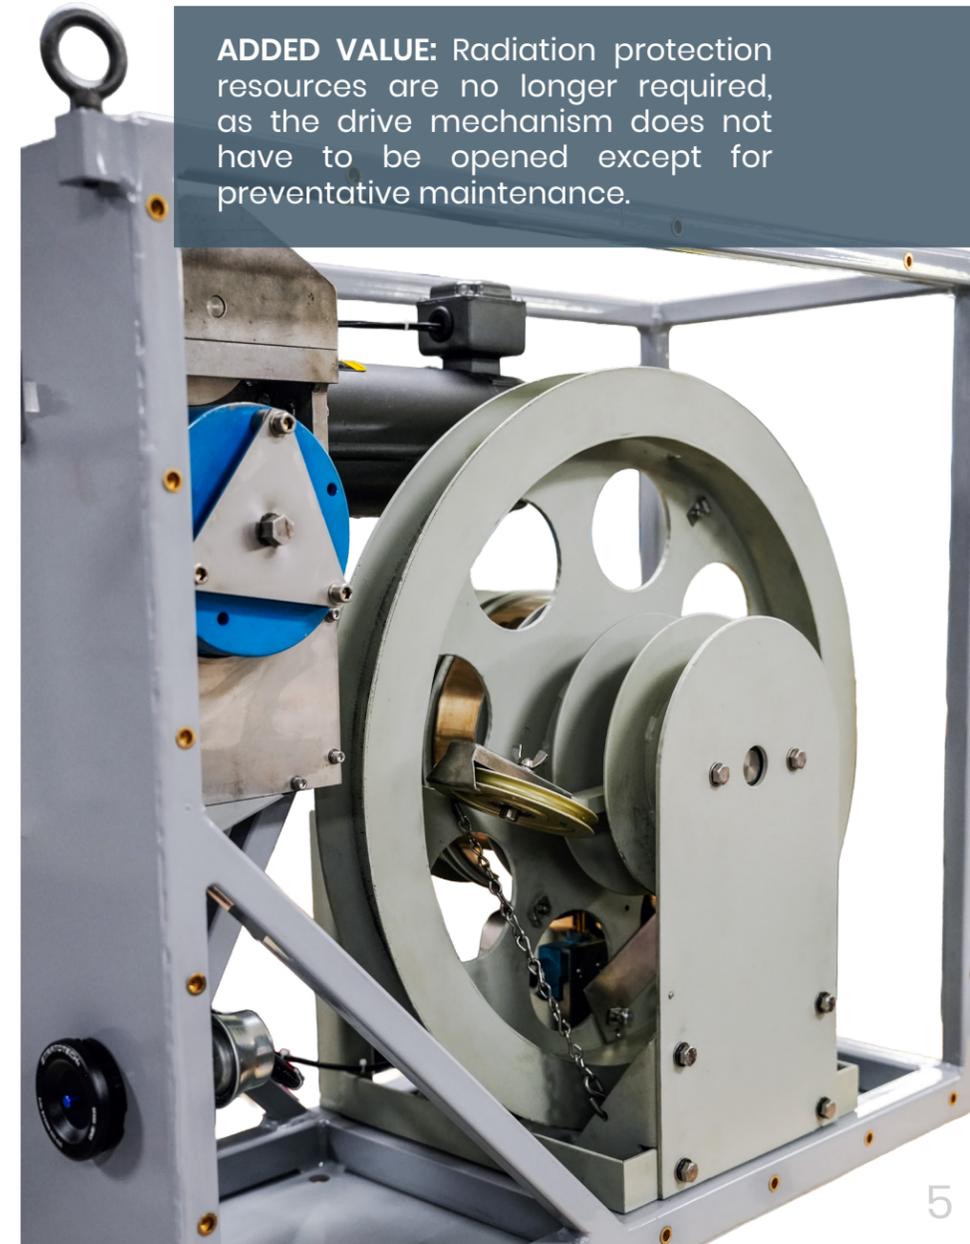
Advantages of an upgraded drive mechanism

Motor is direct drive.

New motor direct drive and position encoder gear drive eliminates maintenance and adjustment of a chain drive (adjusting chain tension, cleaning and lubricating the chain, etc.)

Replaced with a gear-driven absolute encoder that is coupled to the drive motor, allowing better interface to new digital electronics and current technology.

De-energizes the motor if a runaway condition develops. A sacrificial beam provides a physical backup to the motor stop switch for increased reliability. The sacrificial beam deforms to dissipate the drive's rotational energy.

Re-designed to be smaller and lighter.

Moved to an external enclosure, minimizing potential radiation exposure associated with the original design.
