Case study: North Sea, United Kingdom

MASTODON tool freed shallow fish in just minutes with little impact at surface

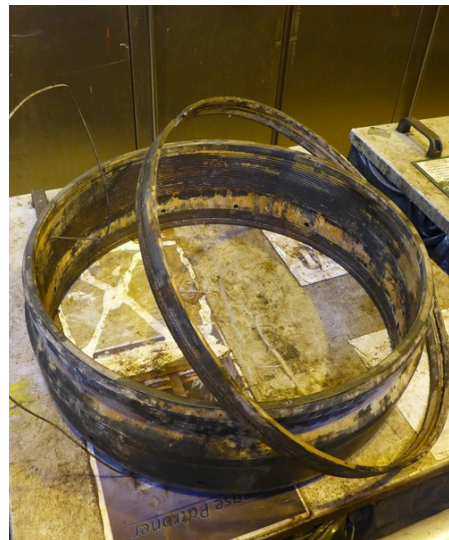
A modified version of the Baker Hughes MASTODON hydraulic pulling tool freed this shallow fish in a matter of mere minutes without any impact on surface equipment.

Typically, the MASTODON tool is anchored in the casing before exerting a pulling force on the fish, transmitting the force to the casing rather than the surface equipment. For this shallow-fish situation, however, the power section of the tool was placed in the rotary with slips and without the anchor section.

The running tool of the LDS was used in conjunction with the MASTODON tool to retrieve the fish. The MASTODON tool's unique method of hydraulically generating the forces downhole was the safest approach to free the fish.
