**Case study:** Onshore, East Java, Indonesia

# TeleCoil service installed expandable casing patches to 7 shut-in wells, brought all back online

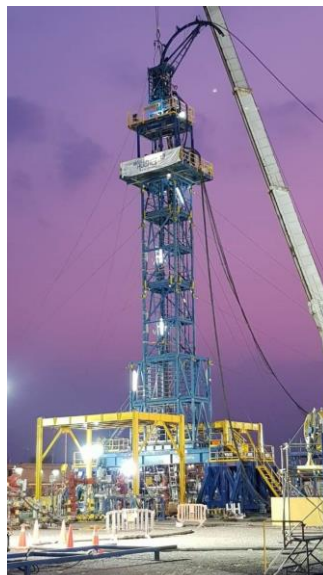
The TeleCoil service eliminates redundant personnel and equipment costs by combining the functionality of conventional coiled tubing and wireline. And since telemetry BHAs can be connected in as little as 30 minutes, the service also reduces downtime between runs.

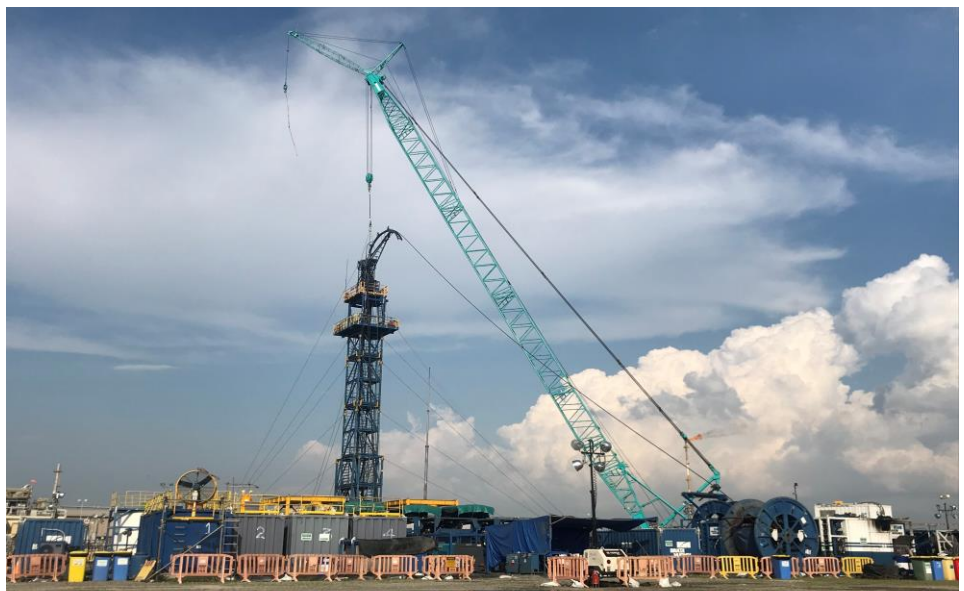
CYCLE pipe management software provides an on-site assessment of the entire coiled tubing string. The software is designed to accurately manage and assess the life span of coiled tubing strings based on fatigue, ballooning,

operation. Both mechanical (bending) fatigue and accelerated fatigue due to H<sub>2</sub>S exposure were monitored on-the-fly using **CIRCA™ RT real-time CT simulation and analysis software** which incorporates the same algorithms as the **CYCLE™ CT fatigue life management software**. The CIRCA RT software provided service delivery benefits by continuously monitoring well and CT pressures and weights and then update safe operating limits. When fatigue in the casing patch depth interval reached a range of 30 to 40%, the string was cut for to avoid high fatigue on the setting depth area.
